## AIRSIDE SAFETY ALERT

Reference	<b>ASA 2020/03</b>		
Date Issued	<b>22/12/2020</b>		
Issued By	<b>Dan Jones</b>	Position	<b>Airside Operations and Safety Manager</b>
Subject	<b>DISCONNECTING TOWBAR FOLLOWING PUSHBACK</b>

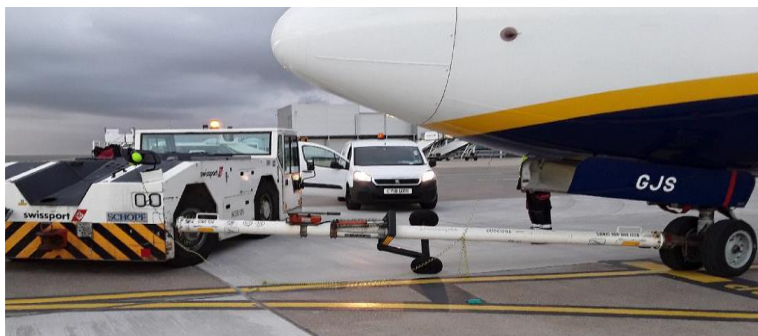
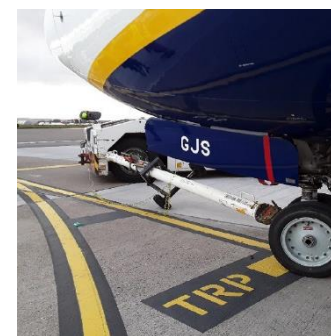
At this point, the tug's offside rear wheel arch came into contact with the towbar. The towbar eye became wedged between the wheel arch and the rear tyre. The towbar was then stuck solid at an angle between the tug's wheel arch and the aircraft nose gear. All passengers and baggage had to be offloaded and transferred to another aircraft and the cul-de-sac was closed. The towbar was later freed and the aircraft returned to service approximately five hours later after an engineering inspection.

Initial findings suggest that the tug has not been reversed far enough from the towbar, before being driven away for the towbar to be reconnected to the rear of the tug. The tug was in rear-wheel drive at the time resulting in the back end of the tug coming closer to the aircraft and towbar.

It is recommended that, after disconnecting the towbar from the pushback tug, that the tug is reversed a **minimum of 5 metres or one towbar length** from the end of the towbar\*. This means that when the tug is driven to the side for the towbar reconnection at the rear of the tug, there is less risk of the tug hitting the towbar.
