AIRSIDE SAFETY ALERT

Reference	ASA 2021/01		
Date Issued	15/02/2021		
Issued By	Dan Jones	Position	Airside Operations and Safety Manager
Subject	STAND ACCESS DURING AIRCRAFT DE-ICING

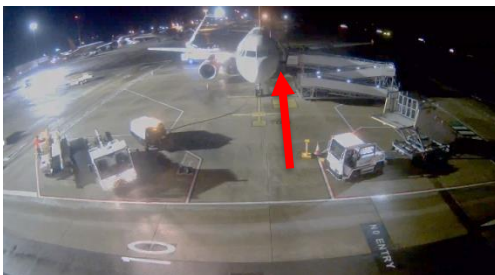
easyJet A319 departing to Edinburgh was de-iced on stand 5 at approximately 0600L on 25th January 2021. All aircraft doors and hatches were closed and no other servicing activities were taking place, when de-icing commenced. Whilst the aircraft was being de-iced (with the de-icing crew operating out of sight on the starboard side), a ground handling agent opened the forward passenger door and the airline crew boarded the aircraft. The aircraft Captain then walked back out of the door and was covered by de-icing fluid. The de-icing crew were unaware that the door had been opened or that crew were in or around the aircraft.

Door opened by Ground Agent

- Whilst aircraft anti-icing or de-icing is in progress, no persons or vehicles shall enter the aircraft footprint (shown below) without authorisation from the de-icing coordinator.
- Aircraft doors must not be open whilst aircraft anti-icing or de-icing is in progress, unless this has been agreed between the de-icing coordinator and the Pilot-in-Command, in advance.
- Passenger steps or aviramp, and all other GSE, should be removed from the aircraft prior to anti-icing or de-icing, so that they do not become contaminated with de-icing fluid.

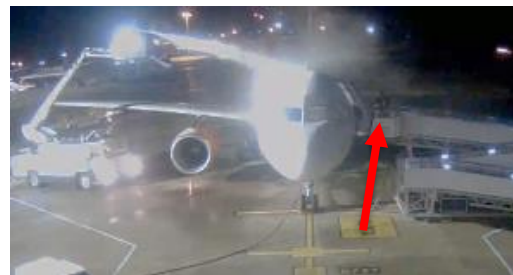
Pilot sprayed with de-icing fluid

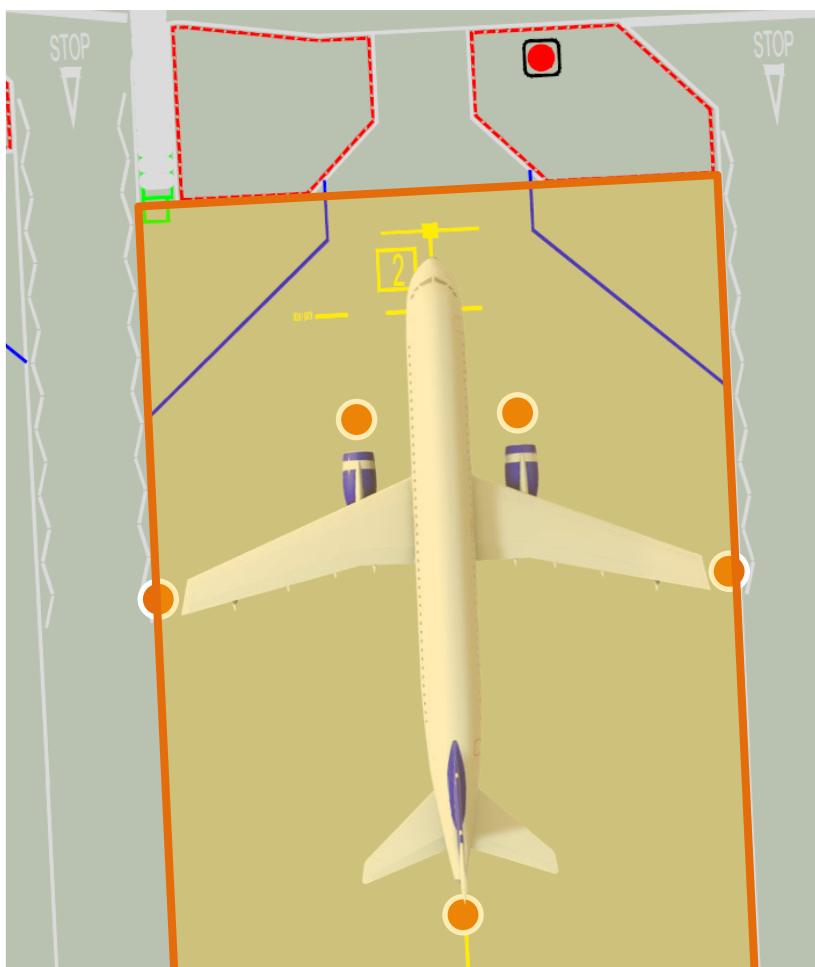
Area not to be entered without authorisation, whilst anti-icing or de-icing is in progress
