AIRSIDE SAFETY ALERT

Reference	ASA 2021/02		
Date Issued	24/02/2021		
Issued By	Dan Jones	Position	Airside Operations and Safety Manager
Subject	DISCONNECTING GPU FROM AIRCRAFT

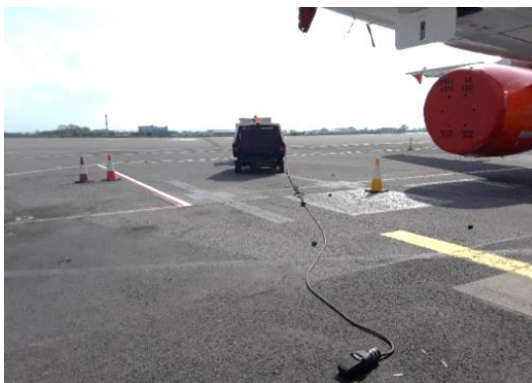
In the previous two years at Bristol Airport, a GPU has been towed away from an aircraft with the GPU plug/cable still connected to the aircraft, on five occasions. These have normally resulted in damage to the GPU plug, damage to the aircraft GPU connection panel, or both. The most recent incident occurred in February 2021.

Trailing cable pulled from the aircraft

1. Check with the flight crew that external power is no longer required.
2. Turn off the GPU.
3. Remove the GPU plug from the aircraft.
4. Store cable in the side of the GPU and insert plug fully into the holder (on some models an alarm will sound if the GPU towing arm is lowered before the plug is returned to the holder).
5. Lower the towing arm and connect to the towing vehicle.
6. Complete a **FULL WALK-AROUND** of the GPU.
7. Remove the chocks.
8. Tow the GPU to an Equipment Parking Area or a marked GPU box, if required.

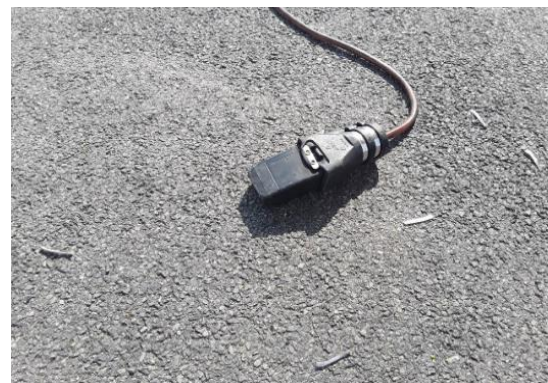
Damaged GPU plug
