OPERATIONAL SAFETY INSTRUCTION

Seatbelt Policy

Issued By Airside Operations and Safety Manager Ref BRS-OSI-DVO-008

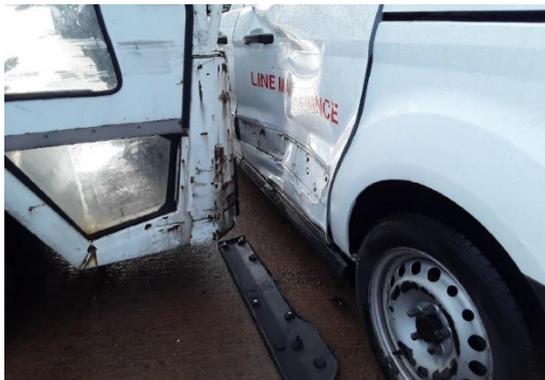
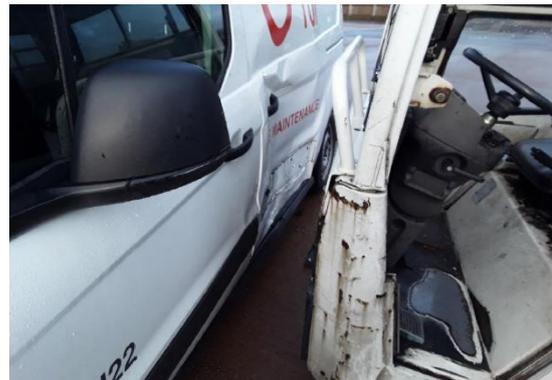
Despite a rigorous airside driving training programme and vehicle familiarisation, ground vehicle collisions can and do happen at airports, including Bristol. The photo below is of a vehicle collision that occurred in January 2020, involving an electric baggage tug (EBT) and an engineering van.

The impact of the EBT forced the van off of the ground on one side and on to two wheels. Had the speed been greater, the momentum could have thrown the drivers from the cab causing serious injury.

It is mandatory that all drivers and passengers wear seatbelts when travelling in a vehicle airside. The following exemptions apply:
