OPERATIONAL SAFETY INSTRUCTION

Seatbelt Policy

Document Owner Head of Airfield Operations Ref BRS-OSI-DVO-008

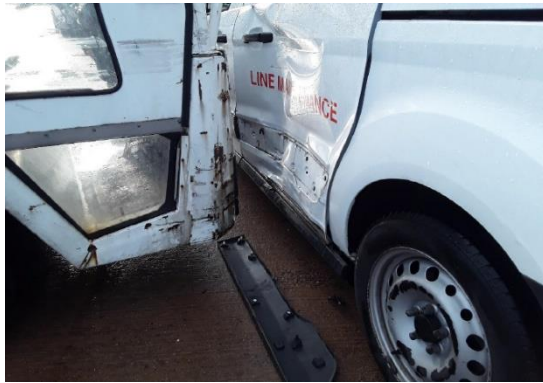
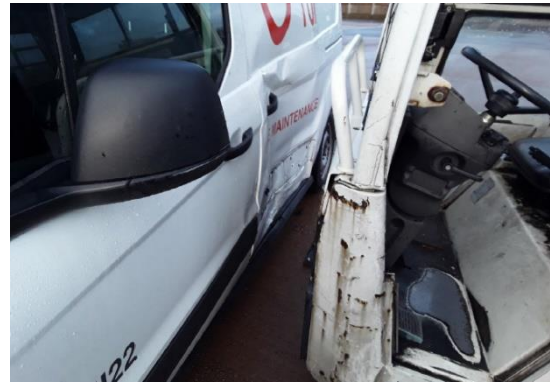
Despite a rigorous airside driving training programme and vehicle familiarisation, ground vehicle collisions can and do happen at airports, including Bristol. The photo below is of a vehicle collision that occurred in January 2020, involving an electric baggage tug (EBT) and an engineering van.

The impact of the EBT forced the van off of the ground on one side and on to two wheels. Had the speed been greater, the momentum could have thrown the drivers from the cab causing serious injury.

It is mandatory that all drivers and passengers wear seatbelts when travelling in a vehicle airside. The following exemptions apply:
