AIRSIDE SAFETY ALERT

Reference	ASA 2021/02		
Date Issued	24/02/2021		
Issued By	Dan Jones	Position	Airside Operations and Safety Manager
Subject	DISCONNECTING GPU FROM AIRCRAFT

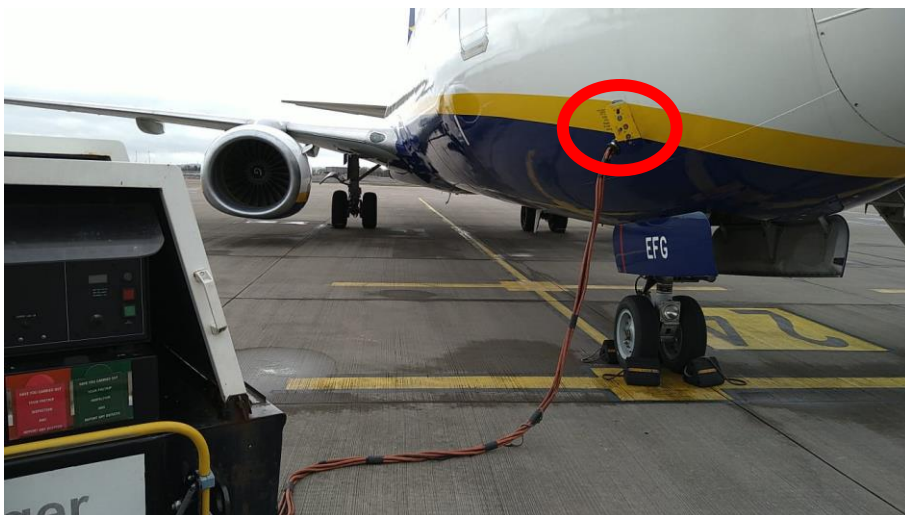
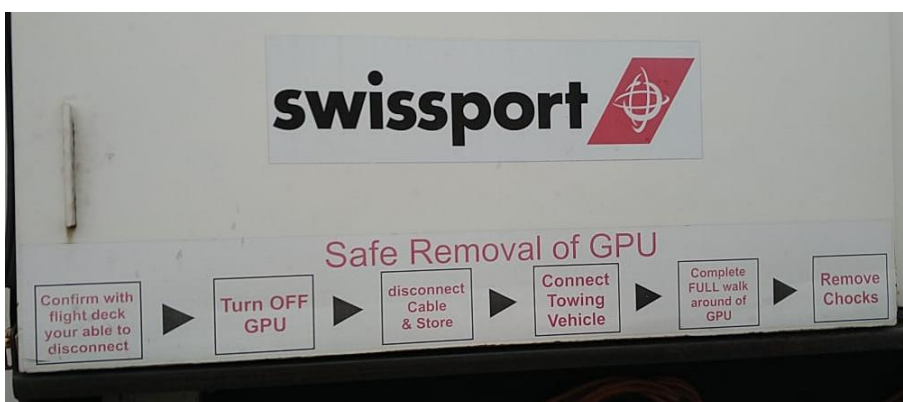
In the previous two years at Bristol Airport, a GPU has been towed away from an aircraft with the GPU plug/cable still connected to the aircraft, on five occasions. These have normally resulted in damage to the GPU plug, damage to the aircraft GPU connection panel, or both. The most recent incident occurred in February 2021.

1. Check with the flight crew that external power is no longer required.
2. Turn off the GPU.
3. Remove the GPU plug from the aircraft.
4. Store cable in the side of the GPU and insert plug fully into the holder (on some models an alarm will sound if the GPU towing arm is lowered before the plug is returned to the holder).
5. Lower the towing arm and connect to the towing vehicle.
6. Complete a **FULL WALK-AROUND** of the GPU.
7. Remove the chocks.
8. Tow the GPU to an Equipment Parking Area or a marked GPU box, if required.
